# A SEM Study Of Copper Corrosion In Bowling Green Supply Lines

A SEM STUDY OF COPPER CORROSION IN BOWLING GREEN SUPPLY LINES

A Thesis  
Presented to  
The Faculty of the Department of Chemistry  
Western Kentucky University  
Bowling Green, Kentucky

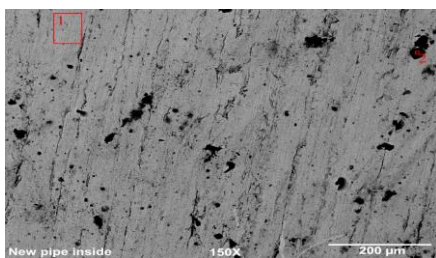
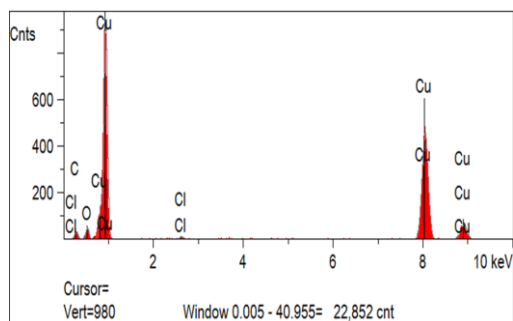
Figure 8: SEM image and analysis of the inside of a new copper pipe.

Figure 7 shows the SEM images of the inside and outside area of a new, uncorroded pipe. The SEM images of the new pipe inside area (Figure 7) indicate the surface is clean and smooth with only a very small amount of “islands” of impurities. On the smooth area, the data shows the surface is predominantly copper as expected [Cu (41.138%), Cl (0.369%), C (46.636%) and O (11.857%)] with slight impurities. Analysis of one of the “islands” shows Cu (7.125%), C (76.941%), O (14.865%), Si (0.108%), P (0.052%), S (0.207%), Cl (0.264%), K (0.276%) Ca (0.046%) and Fe (0.117%). SEM images from the same pipe, but on the outside (Figure 8) show a surface that is still relatively clean, but with a slight increase in impurities. Four spots for selected for elemental analysis – two from clean areas and two from impurities. The clean spots indicated predominantly copper with a few trace elements such as Na, Mg, Al, Si, Cl, K and Ca. The impurity areas, which are likely to be copper oxide, had higher levels of trace elements. There are more impurities on the outside and are likely to include  $\text{Al}_2\text{O}_3$ ,  $\text{SiO}_2$  and  $\text{CaCO}_3$ , which were not observed on the inside area. The brown boxes on the SEM images show the areas that were analyzed.

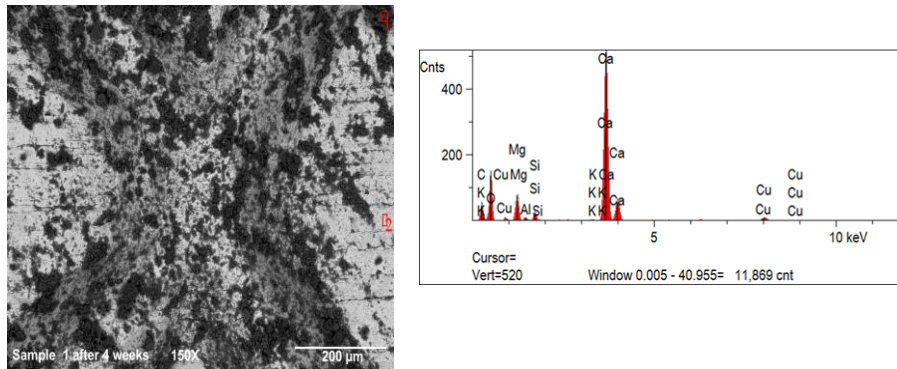
Figure 17: SEM image and analysis of new pipe and limestone after four weeks

Figure 16 shows the SEM image of new pipe and limestone after four weeks. From the SEM image, we can see a lot of black particles or spots and a two rod like structures. EDS data were taken on two spots. Spot one is on the area with clear Surface. Spot 2 is the place with more big black particles. The table shows the atomic percentage of the elements present in on the two spots.

The percetage of oxygen is higher in the 4 weeks interaction than in the 2 weeks interaction. We also see the presence of copper which is from the limestone. The percentage of copper has also decreased in great value. The percentage of oxgyen has also increased.

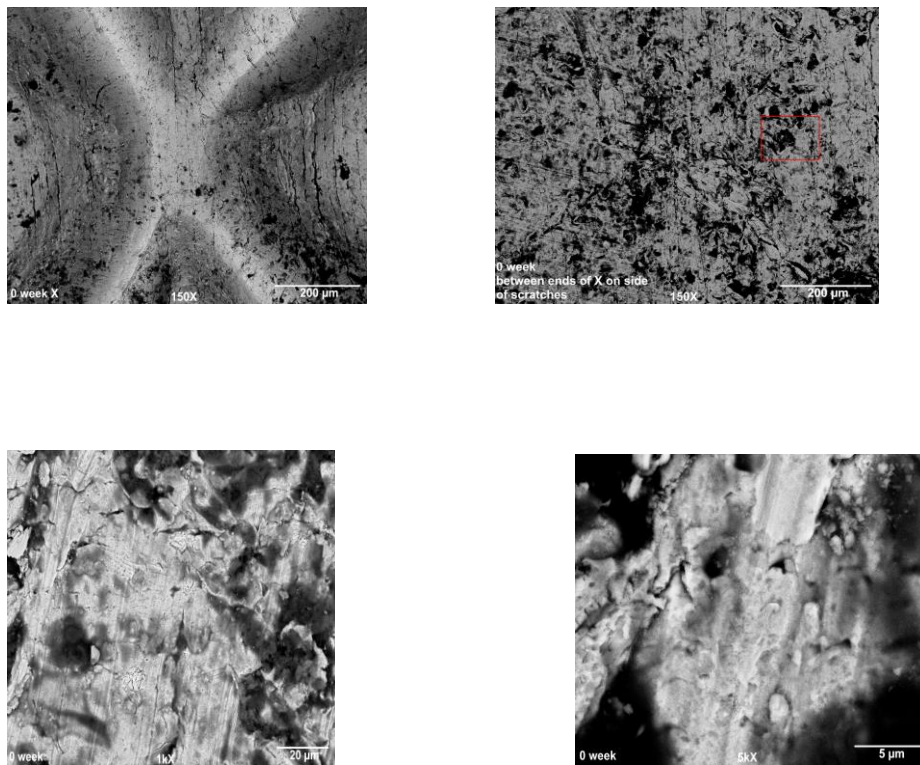
Figure 18: SEM image and analysis of flat clean copper pipe

Figure 17 shows the SEM image of flat clean copper pipe. The SEM image of the X scratch is very clean. SEM images between the two ends of the X scratch were also analyzed. While there are both spot and bright spots, the surface is generally very clean and smooth and contains mostly copper while the spots are probably mostly copper oxide.
